**Flood Control Project Maintenance  
Levee Inspections**

## Maintenance Issue Types Only, Levee Inspection Report By Mile - Fall 2015

### Plumas County

Waterway	Bank	Unit Miles	Inspection Start/End	Inspector
Unit No. 01 North Fork Feather River	Left	1.89	09/29/2015 09/29/2015	Bob Duffey

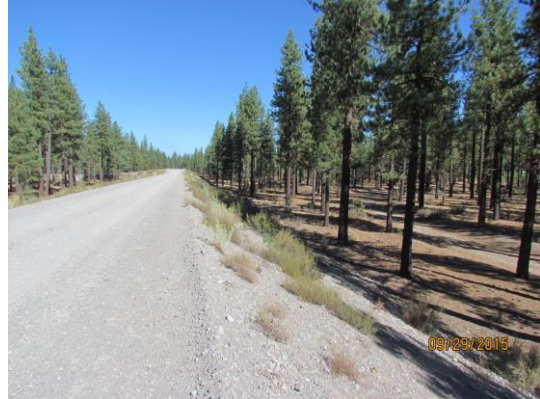
Photo 1 of 1 : FA\_2015\_NA0015\_337\_11\_20151012\_00010.jpg

LM Start	0.00	Rating **	M	Issue No.	11
LM End	1.89	Issue Type +	Ma	Location *	LS
Category	Earthen Levee			GPS Latitude/Longitude	
				Start	End
Item	Vegetation			40.273168 °	40.297283 °
				-121.244783 °	-121.257025 °
DWR ID	DWR_NA0015_01_f_2015_11				
Action/Comments					
Remove the wild growth other than native grasses from the levee slopes.					
Inspector Comments: Remove the small pine trees and other vegetation from the levee slope.

Remove the small pine trees and other vegetation from the levee slope.

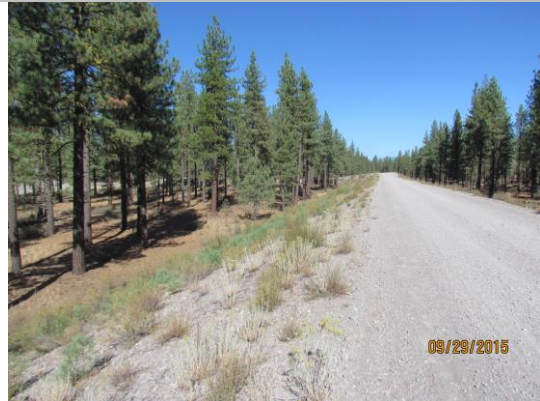
Photo 1 of 1 : FA\_2015\_NA0015\_337\_12\_20151012\_00009.jpg

LM Start	0.00	Rating **	M	Issue No.	12
LM End	1.89	Issue Type +	Ma	Location *	WS
Category	Earthen Levee			GPS Latitude/Longitude	
				Start	End
Item	Vegetation			40.273168 °	40.297283 °
				-121.244783 °	-121.257025 °
DWR ID	DWR_NA0015_01_f_2015_12				
Action/Comments					
Remove the wild growth other than native grasses from the levee slopes.					
Inspector Comments: Remove all small pine trees and other vegetation from the levee slope.

View of the small pine trees and other vegetation on the slope.

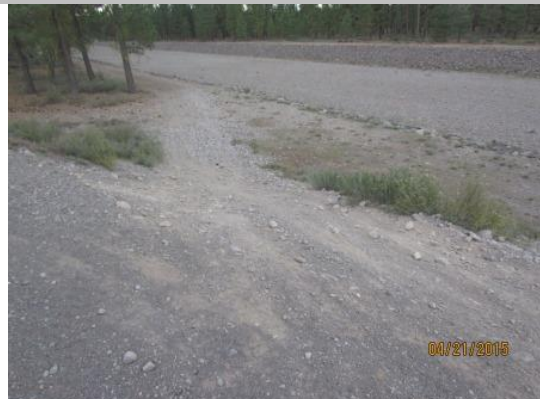
Photo 1 of 1 : FA\_2015\_NA0015\_337\_9\_20150910\_00007.jpg

LM Start	0.55	Rating **	M	Issue No.	9
LM End	0.55	Issue Type +	Ma	Location *	WS
Category	Earthen Levee			GPS Latitude/Longitude	
				Start	End
Item	Slope Stability			40.279790 °	121.249850 °
				40.279790 °	121.249850 °
DWR ID	DWR_NA0015_01_s_2012_9				
Action/Comments					
Repair the levee slope damaged by vehicle traffic and prevent access where possible.

View of the vehicle erosion along the waterside toe.

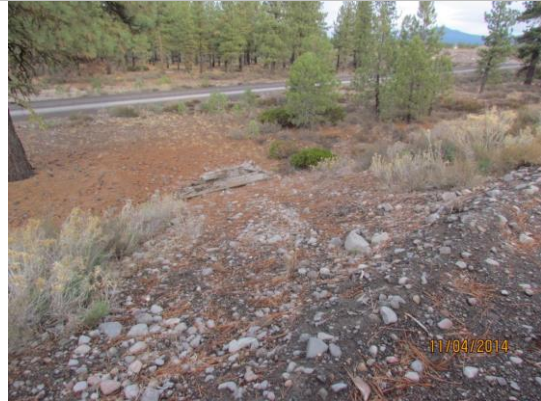
Photo 1 of 1 : FA\_2015\_NA0015\_337\_5\_20150910\_00002.jpg

LM Start	0.96	Rating **	M	Issue No.	5
LM End	0.96	Issue Type +	Ma	Location *	WS
Category	Earthen Levee			GPS Latitude/Longitude	
				Start	End
Item	Slope Stability			40.285363 °	40.285363 °
				-121.251973 °	-121.251973 °
DWR ID	DWR_NA0015_01_f _ 2013_5				
Action/Comments					
Repair the levee slope damaged by vehicle traffic and prevent access where possible.

View of the vehicle erosion along the waterside slope.

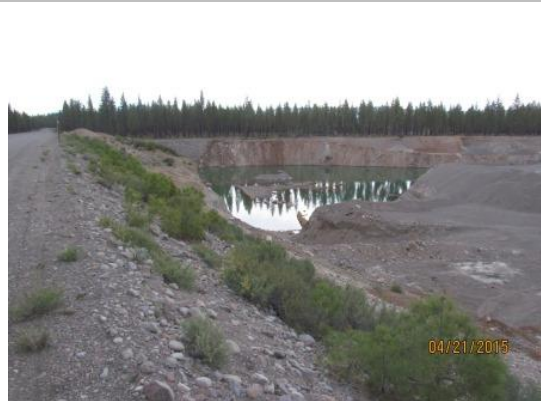
Photo 1 of 2 : FA\_2015\_NA0015\_337\_7\_20150910\_00004.jpg

LM Start	1.41	Rating **	U	Issue No.	7
LM End	1.50	Issue Type +	Ma	Location *	LS
Category	Earthen Levee			GPS Latitude/Longitude	
				Start	End
Item	Slope Stability			40.290758 °	40.291987 °
				-121.255402 °	-121.256072 °
DWR ID	DWR_NA0015_01_f_2014_7				
Action/Comments					
Repair slope instability. Inspector Comments: The landowner needs to replace the material that has been removed from the toe of the levee.

View of the area where the contractor has removed the material from toe of the levee.

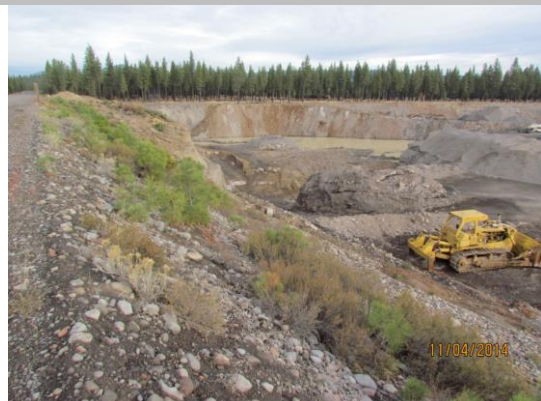
Photo 2 of 2 : FA\_2015\_NA0015\_337\_7\_20150910\_00005.jpg

View of the area where the contractor has removed the material from toe of the levee.

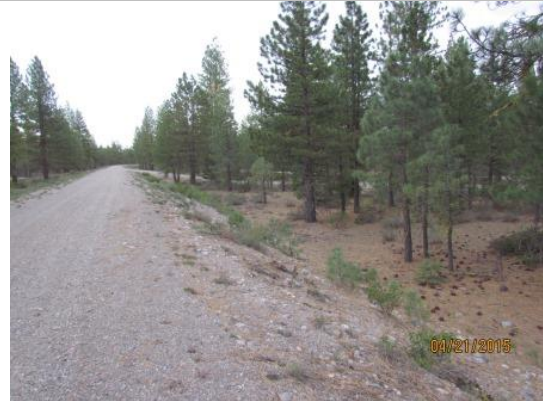
Photo 1 of 2 : FA\_2015\_NA0015\_338\_1\_20150910\_00001.jpg

LM Start	0.03	Rating **	M	Issue No.	1
LM End	1.36	Issue Type +	Ma	Location *	LS
Category	Earthen Levee			GPS Latitude/Longitude	
				Start	End
Item	Vegetation			40.286415 °	40.271743 °
				-121.259613 °	-121.246805 °
DWR ID	DWR_NA0015_02_f_2012_1				
Action/Comments					
Remove the wild growth other than native grasses from the levee slopes.					
Inspector Comments: Mow or remove the pine trees and other vegetation from the slope.

View of the small pine trees growing on the landside slope.

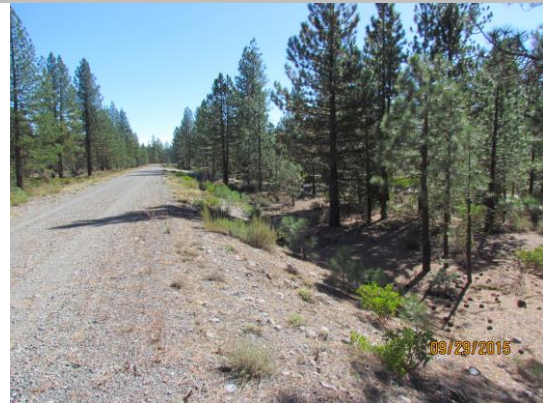
Photo 2 of 2 : FA\_2015\_NA0015\_338\_1\_20151012\_00009.jpg

View of the small pine trees and other vegetation growing on the slope.

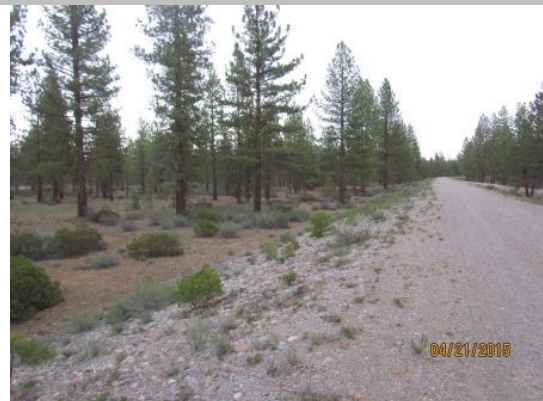
Photo 1 of 2 : FA\_2015\_NA0015\_338\_2\_20150910\_00002.jpg

LM Start	0.03	Rating **	M	Issue No.	2
LM End	1.36	Issue Type +	Ma	Location *	WS
Category	Earthen Levee			GPS Latitude/Longitude	
				Start	End
Item	Vegetation			40.286415 °	40.271743 °
				-121.259613 °	-121.246805 °
DWR ID	DWR_NA0015_02_f_2012_2				
Action/Comments					
Remove the wild growth other than native grasses from the levee slopes.					
Inspector Comments: Mow or remove the pine trees and other vegetation from the slope.

View of the small pine trees growing on the waterside slope.

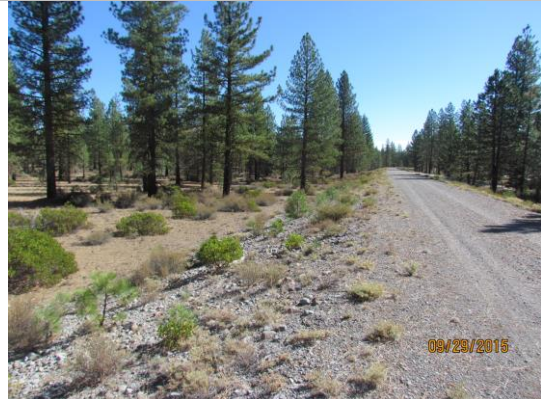
Photo 2 of 2 : FA\_2015\_NA0015\_338\_2\_20151012\_00008.jpg

LM Start	0.03	Rating **	M	Issue No.	2 (cont)
LM End	1.36	Issue Type +	Ma	Location *	WS
Category	Earthen Levee			GPS Latitude/Longitude	
				Start	End
Item	Vegetation			40.286415 °	40.271743 °
				-121.259613 °	-121.246805 °
DWR ID	DWR_NA0015_02_f_2012_2				
Action/Comments					
Remove the wild growth other than native grasses from the levee slopes.					
Inspector Comments: Mow or remove the pine trees and other vegetation from the slope.

View of the small pine trees and other vegetation growing on the slope.

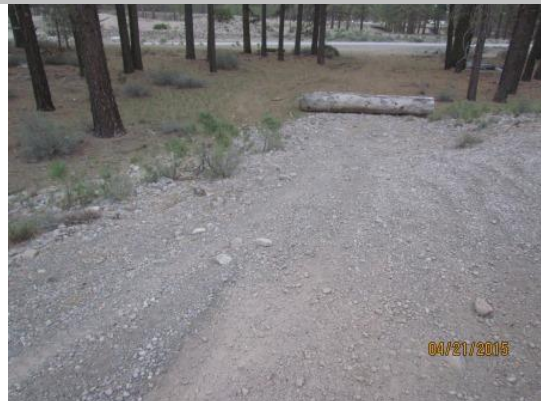
Photo 1 of 2 : FA\_2015\_NA0015\_338\_6\_20150910\_00005.jpg

LM Start	0.46	Rating **	M	Issue No.	6
LM End	0.46	Issue Type +	Ma	Location *	WS
Category	Earthen Levee			GPS Latitude/Longitude	
				Start	End
Item	Slope Stability			40.283059 °	40.283059 °
				-121.253989 °	-121.253989 °
DWR ID	DWR_NA0015_02_f_2013_6				
Action/Comments					
Repair the levee slope damaged by vehicle traffic and prevent access where possible.

View of the vehicle erosion on the waterside slope.

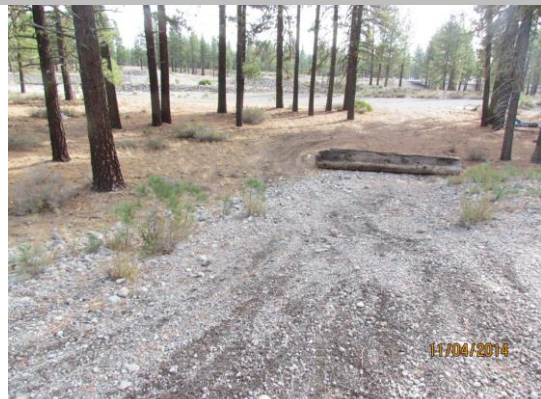
Photo 2 of 2 : FA\_2015\_NA0015\_338\_6\_20150910\_00006.jpg

View of the vehicle erosion on the landside slope.

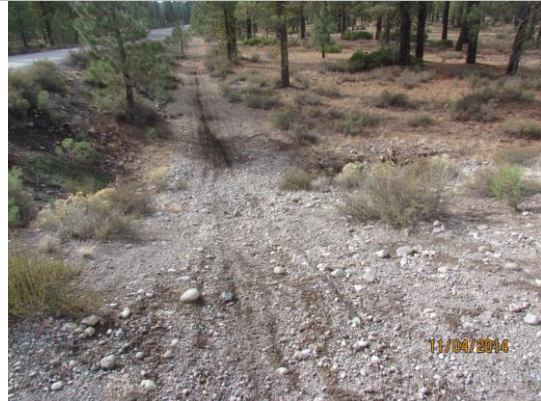
Photo 1 of 1 : FA\_2015\_NA0015\_338\_4\_20150910\_00003.jpg

LM Start	0.55	Rating **	M	Issue No.	4
LM End	0.55	Issue Type +	Ma	Location *	LS
Category	Earthen Levee			GPS Latitude/Longitude	
				Start	End
Item	Slope Stability			40.281950 °	121.253710 °
				40.281950 °	121.253710 °
DWR ID	DWR_NA0015_02_s _ 2012_4				
Action/Comments					
Repair the levee slope damaged by vehicle traffic and prevent access where possible.

View of the slope instability cause by vehicle along the landside slope.

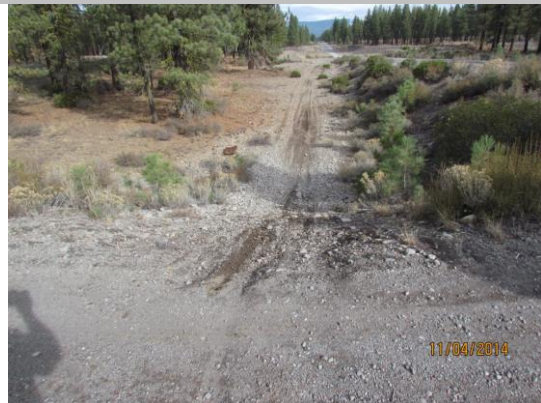
Photo 1 of 1 : FA\_2015\_NA0015\_338\_5\_20150910\_00004.jpg

LM Start	0.55	Rating **	M	Issue No.	5
LM End	0.55	Issue Type +	Ma	Location *	WS
Category	Earthen Levee			GPS Latitude/Longitude	
				Start	End
Item	Slope Stability			40.281950 °	121.253710 °
				40.281950 °	121.253710 °
DWR ID	DWR_NA0015_02_s _ 2012_5				
Action/Comments					
Repair the levee slope damaged by vehicle traffic and prevent access where possible.

View of the vehicle erosion on the waterside slope.
